## INSPECTION REPORT

1234 Main Street  
Katy TX 77494

# PROPERTY INSPECTION REPORT FORM

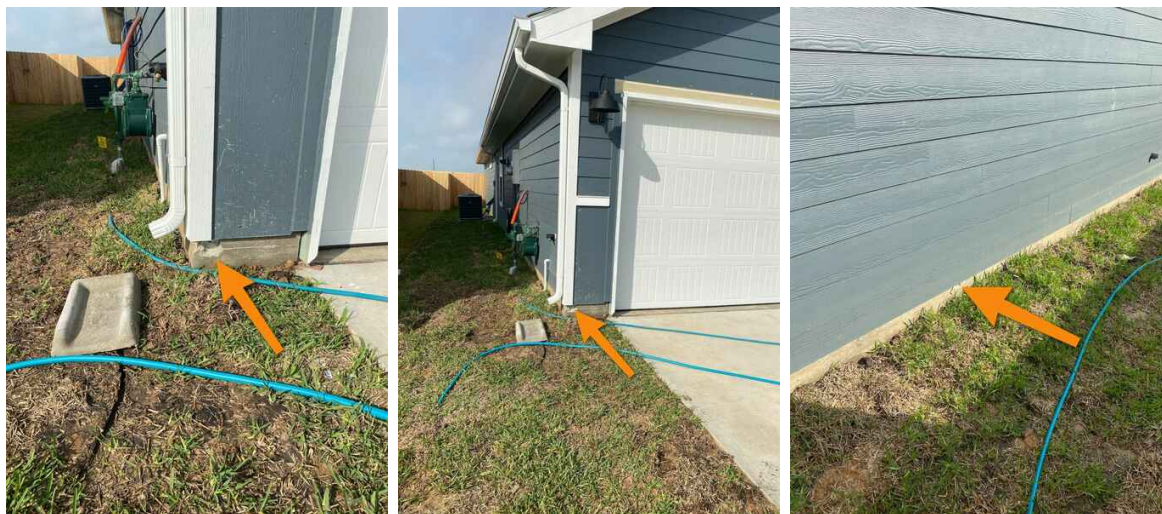
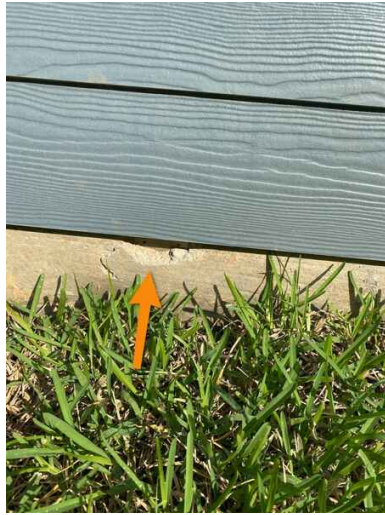
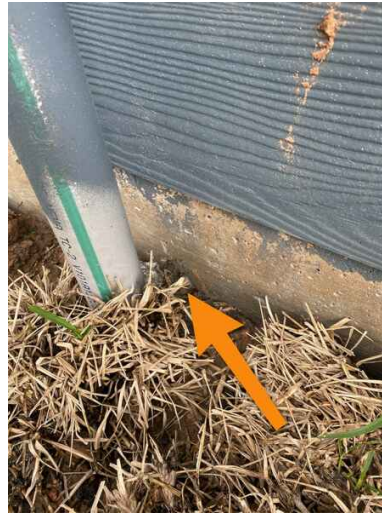
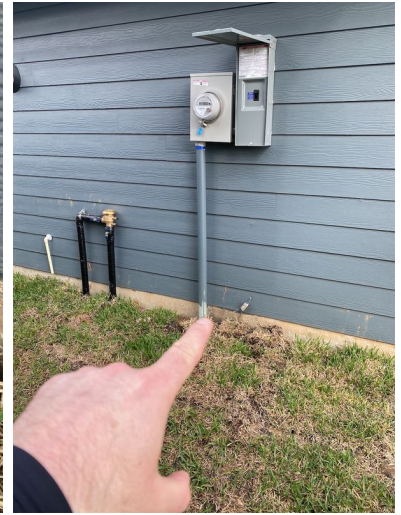
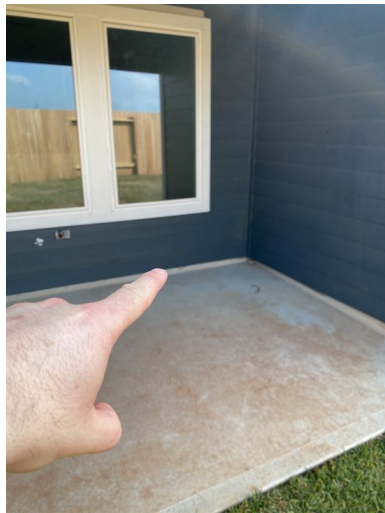
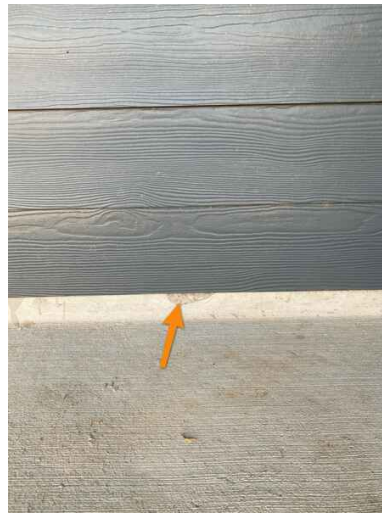
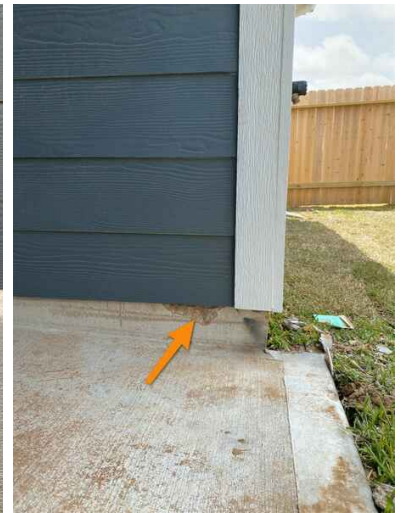
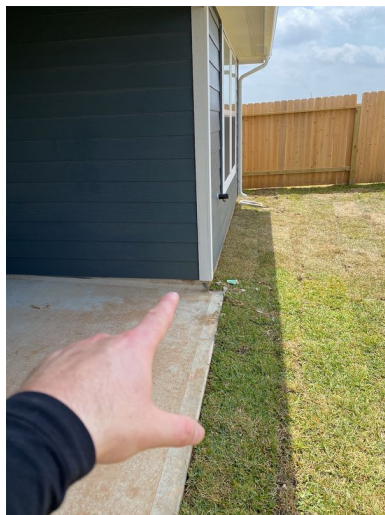
**1: Slab - Corner Crack/Pop**

One or more of the foundation perimeter beams were observed to be cracked or sheared off. This is a common condition in slab-on-grade foundations. This condition does not adversely affect the performance of the foundation. However, in some cases, some cosmetic improvements may be necessary

Recommendation: Contact a qualified professional.

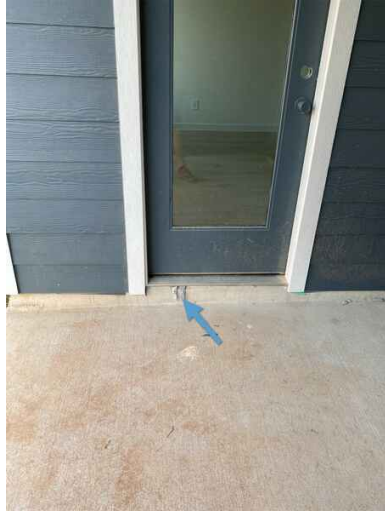
**2: Metal bracket**

Metal bracket was observed at the rear patio door. Recommend removal.

Recommendation: Contact a qualified professional.

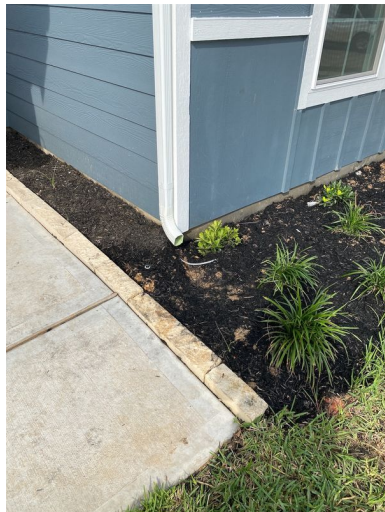
**1: Missing downspout kick-out or extension**

A missing downspout kick-out(s) or extension(s) was observed. Downspouts should discharge at least 5 feet away from the foundation; if not corrected, this could cause foundation issues. Recommend installing or extending out from the foundation.

Recommendation: Contact a handyman or DIY project

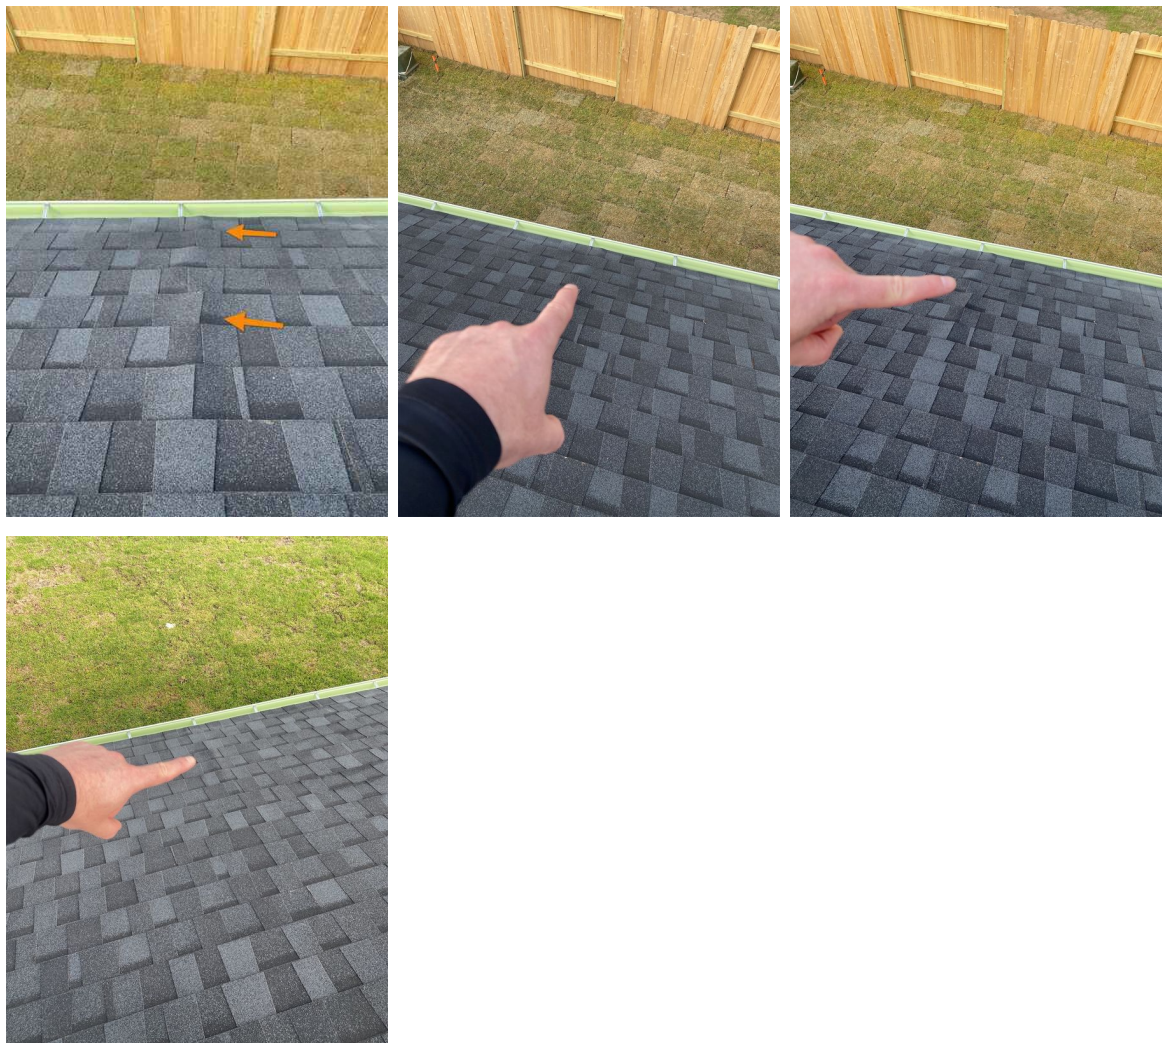
**1: Roof – Racking shingles**

Racking shingle was observed at the right and rear of the roof. Recommend correcting.

Recommendation: Contact a qualified professional.

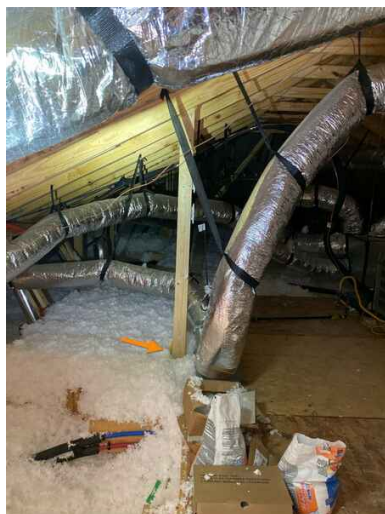
**1: Loose framing member**

A loose framing member was observed in the attic near the furnace. Recommend correcting.

Recommendation: Contact a qualified professional.

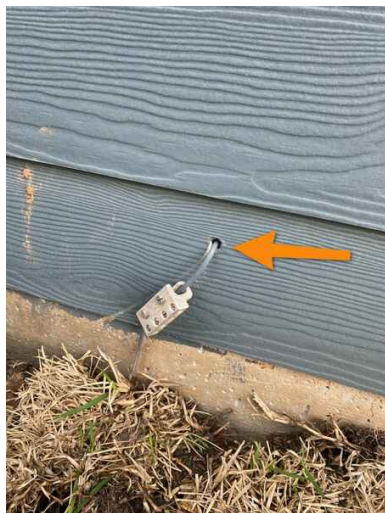
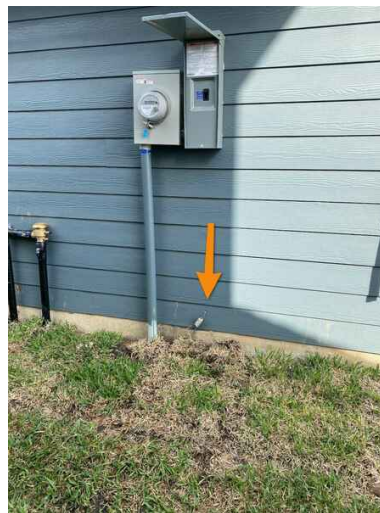
**1: Exterior - Siding Holes**

Unsealed holes were observed at the exterior wall cladding. Recommend repair.

Recommendation: Contact a qualified professional.

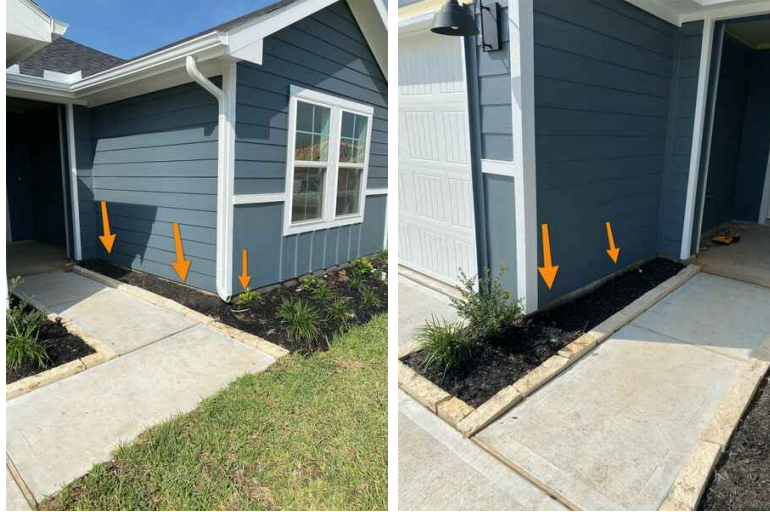
**2: Exterior - Siding Clearance to Grade**

Inadequate clearance was observed between the wall cladding and the grade. Recommend correcting.

Recommendation: Contact a qualified Grading/Drainage Contractor

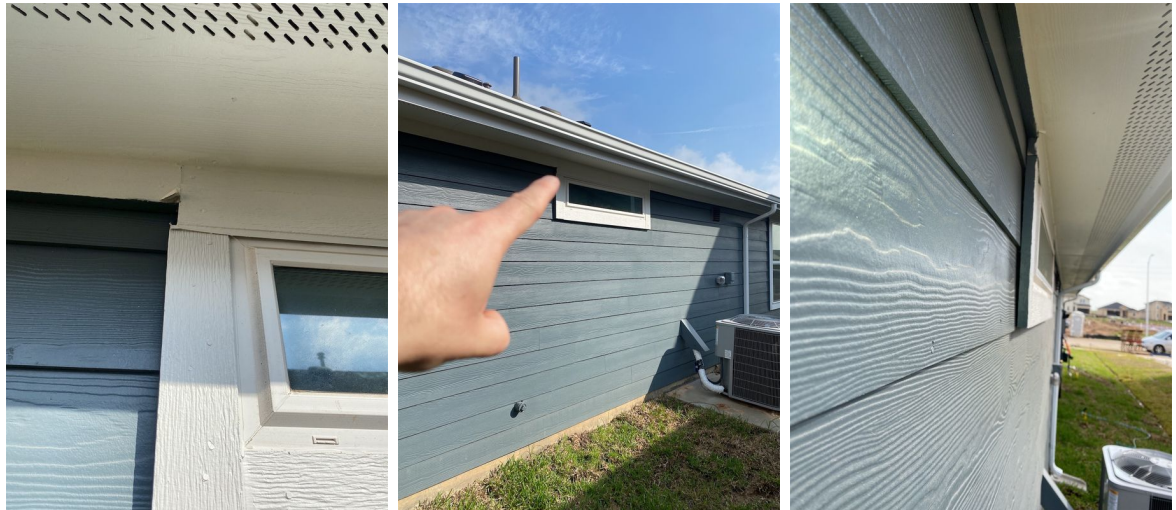
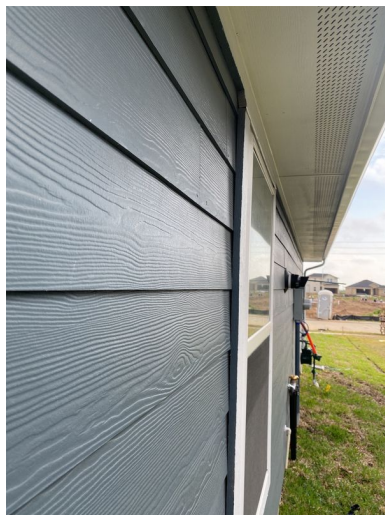
**3: Exterior - Trim voids**

The window trim was incorrectly installed; it observed all the windows. Recommend correcting.

TRIM APPLICATION FOR WINDOWS, DOORS & OTHER OPENINGS  
Flashing over trim is required per code for all installation methods. (Figure 14)

Recommendation: Contact a qualified professional.

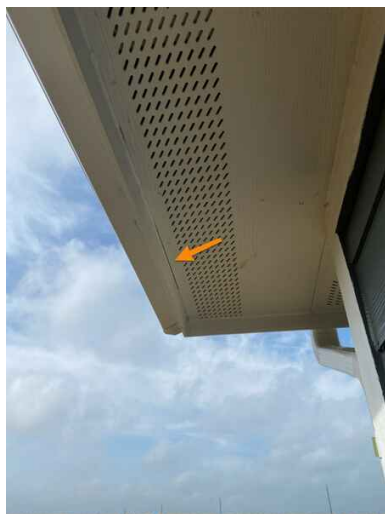
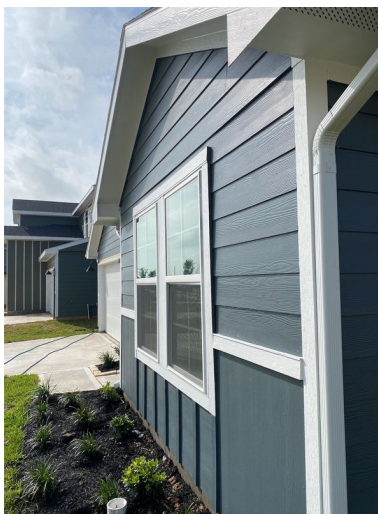
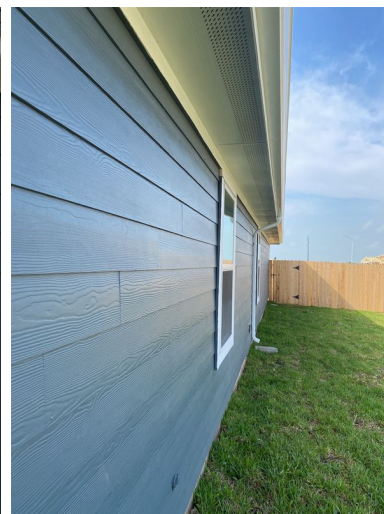
**4: Exterior – Deteriorated caulking**

Deteriorated/missing caulking was observed in a number of areas on the exterior. Recommend caulking.

Recommendation: Contact a qualified professional.

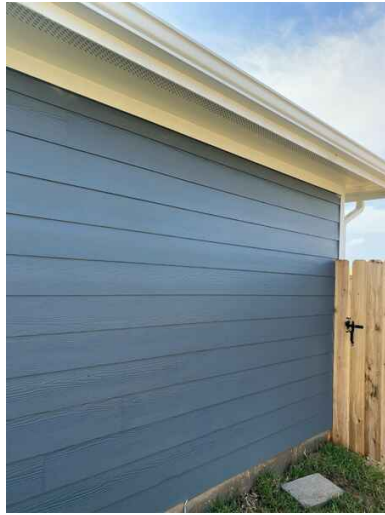
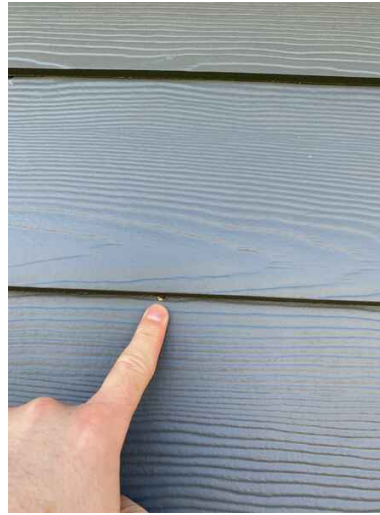
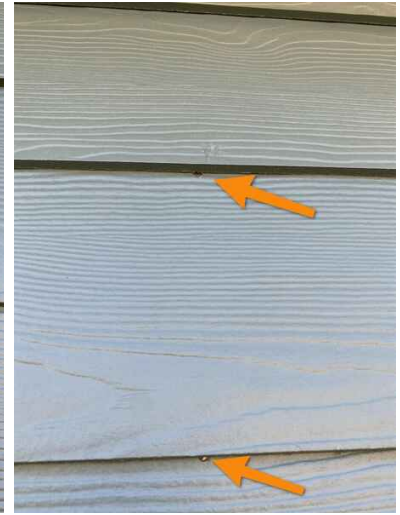
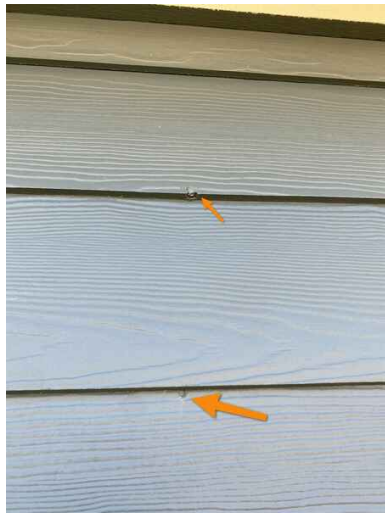
**5: Exterior – Overdriven siding nails**

Overdriven siding nails were observed on the right side near the rear fence. Recommend correcting.

Recommendation: Contact a qualified professional.

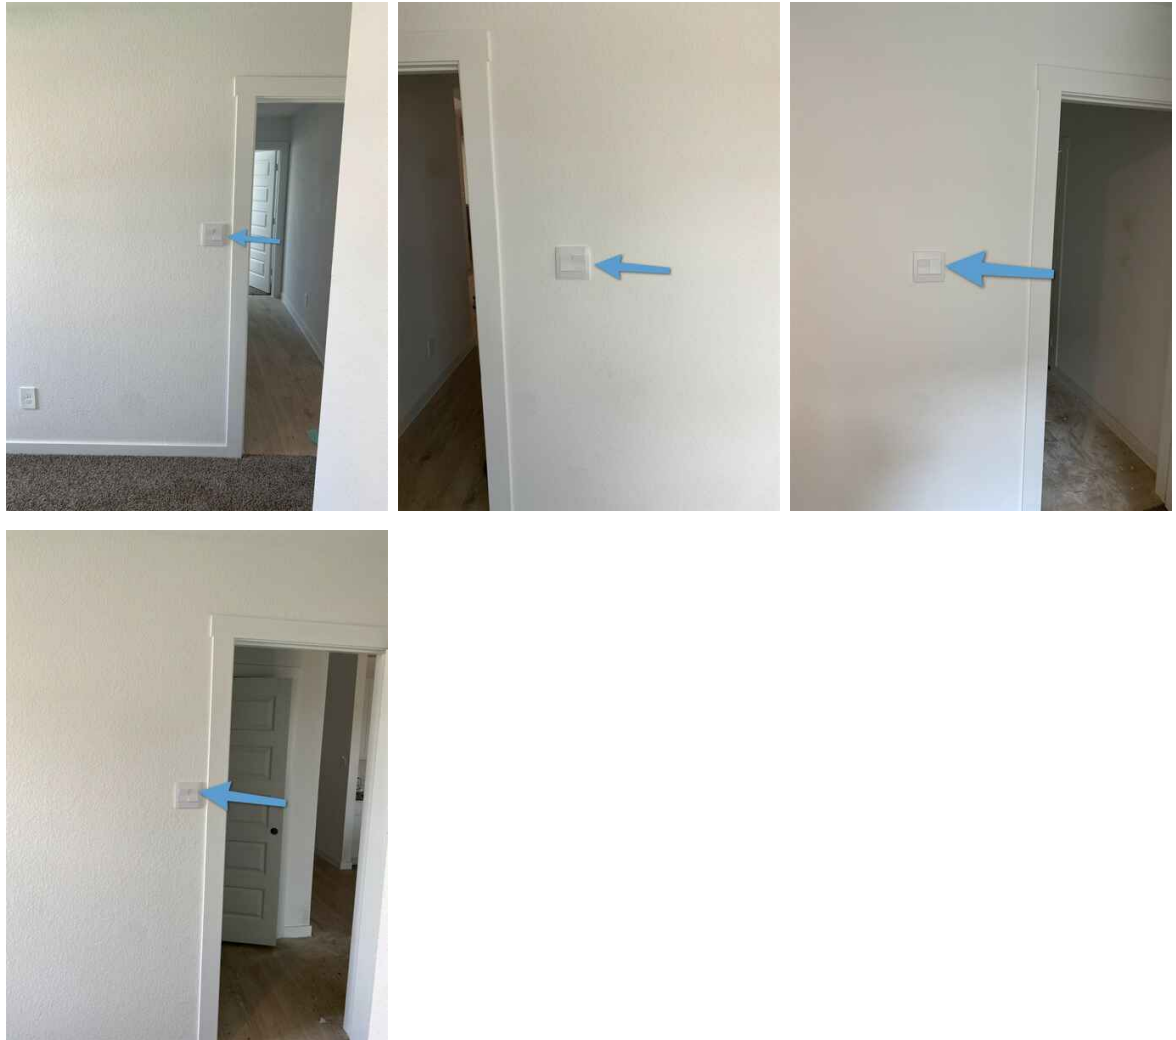
**1: Light Switch Use (Interior)**

Unable to determine use for light switch at the guest bedrooms.

Recommendation: Contact a qualified professional.

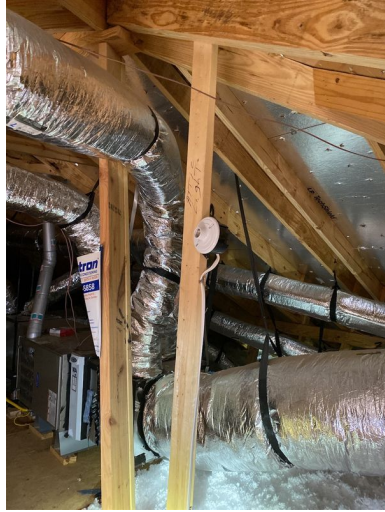
**2: Fixture - Missing lightbulb**

Missing lightbulb was observed in the attic. Recommend installing.

Recommendation: Contact a qualified professional.

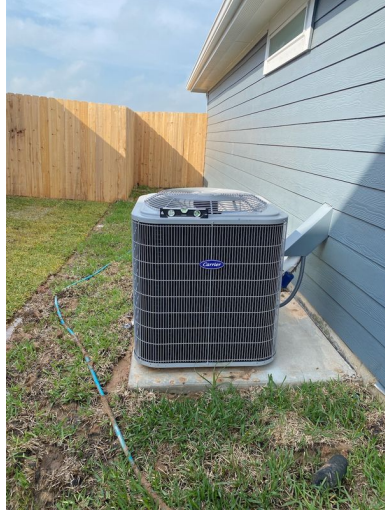
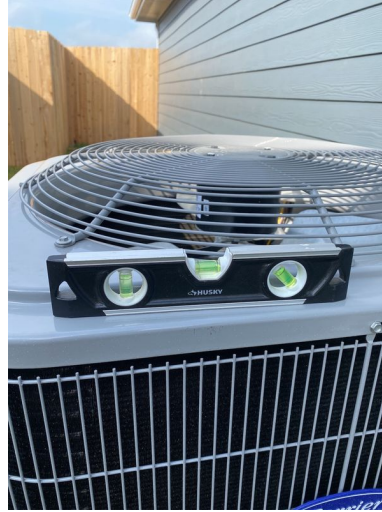
**1: Unit Not Level**

Concrete pad supporting the outdoor condensing unit is not level. This can cause accelerated deterioration of components. Recommend licensed HVAC contractor level the unit.

Recommendation: Contact a qualified HVAC professional.

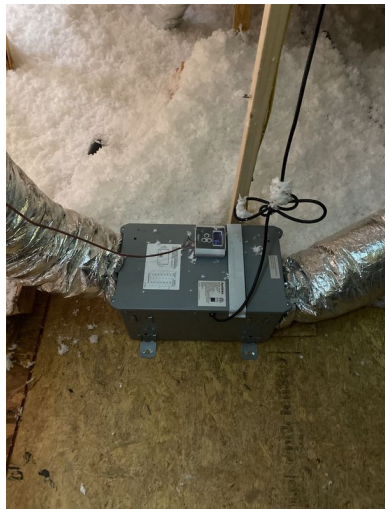
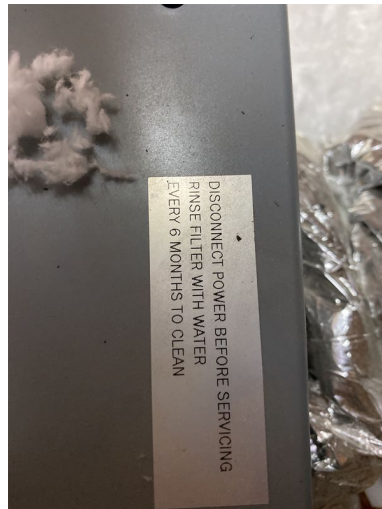
*Limited review - fresh air controller:*

A fresh air venting system was observed in the attic. This is beyond the inspection scope.

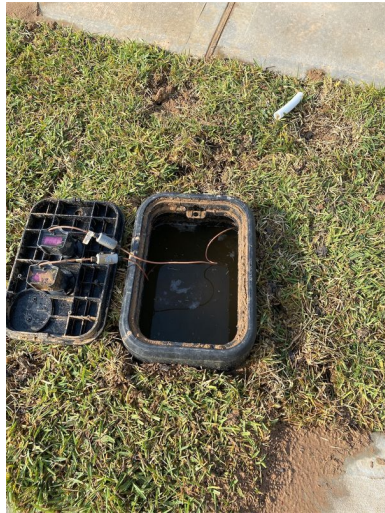
**1: Meter - Flooded Crock**

Water meter crock was flooded at time of inspection. Recommend further review by a qualified plumber, prior to the end of the contingency period.

Recommendation: Contact a qualified professional.

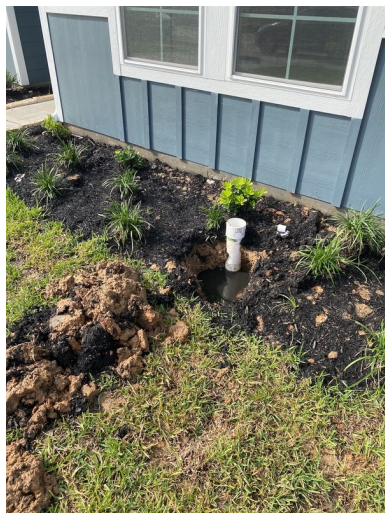
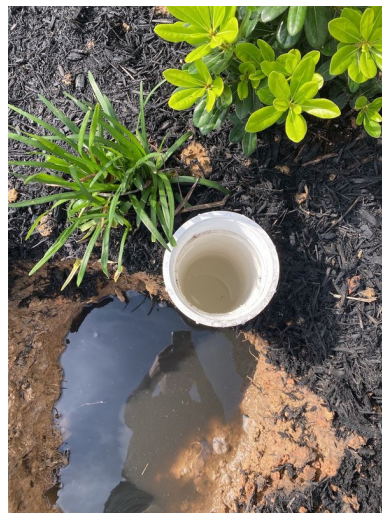
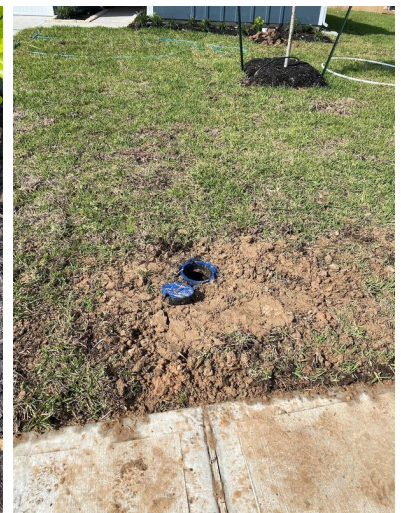
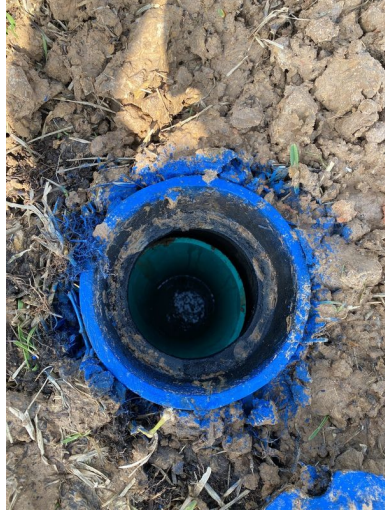
**1: Sewer clean out clogged**

Standing water was observed at the sewer cleanout. Recommend further review by qualified plumber prior to the end of the contingency.

Recommendation: Contact a qualified professional.

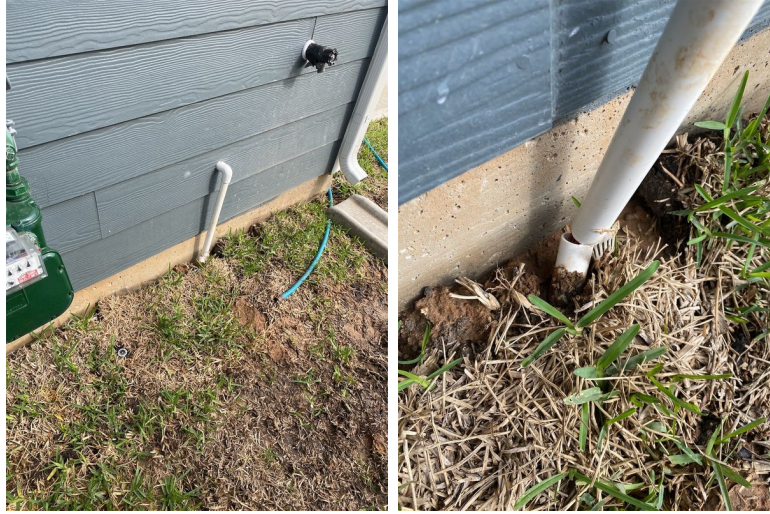
**1: Exposed low-voltage wires**

Expose low-voltage wires observed. Recommend correcting.

Recommendation: Contact a qualified professional.
